**Flood Control Project Maintenance
Levee Inspections
LMA District Cover Sheet
Spring 2010 Levee Inspection Results**

Reclamation District No. 0307 Lisbon

Levee Inspection Report By Mile - Spring 2010

Waterway						Bank	Unit Miles	Inspection Start/End	Inspector
Unit No. 01 Sacramento River						Right	6.65	04/14/2010 04/17/2010	Herman Phillips

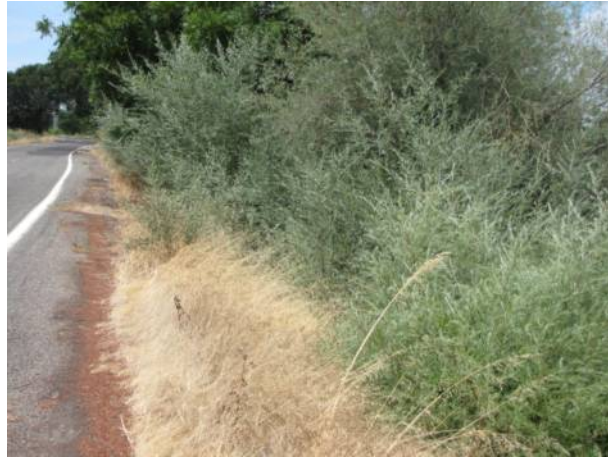
Levee Mile Report Line	36
Start Levee Mile	2.81
End Levee Mile	3.02
Location	Water Side
Category	Earthen Levee
Item	Vegetation

Levee mile 2.81 looking downstream to levee mile 3.02 wild growth has covered the levee slopes completely blockingf view of levee section. Standing on landside.

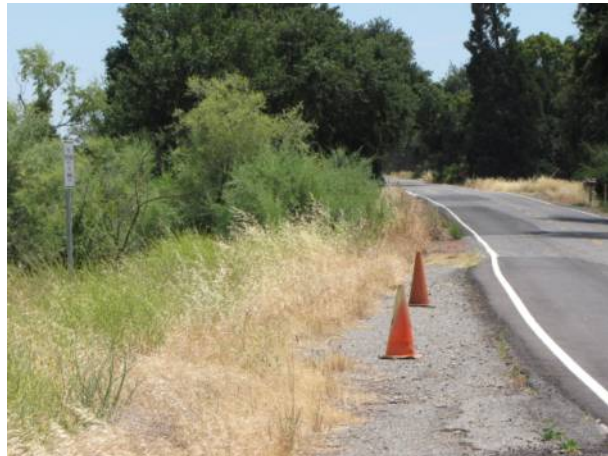
Levee Mile Report Line	36
Start Levee Mile	2.81
End Levee Mile	3.02
Location	Water Side
Category	Earthen Levee
Item	Vegetation

Standing on the landside looking back upstream from levee mile 2.81.

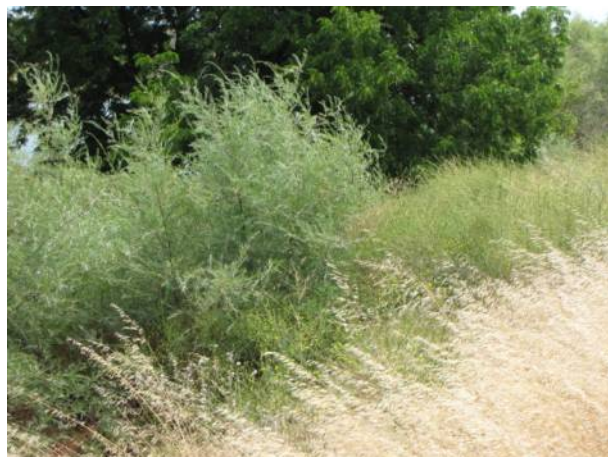
Levee Mile Report Line	36
Start Levee Mile	2.81
End Levee Mile	3.02
Location	Water Side
Category	Earthen Levee
Item	Vegetation

Looking from levee mile 3.02 looking downstream at the wild growth covers the levee slope.

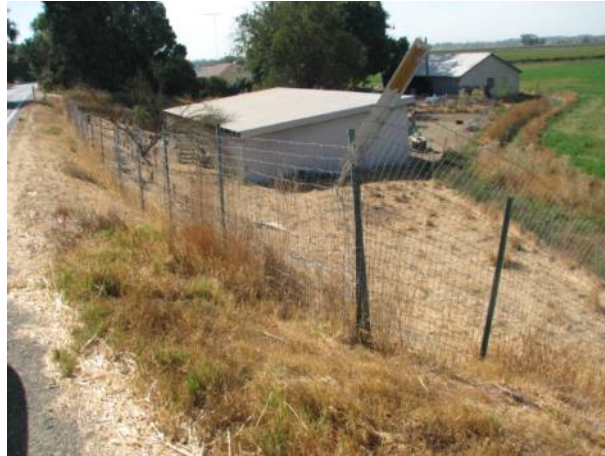
Levee Mile Report Line	37
Start Levee Mile	2.99
End Levee Mile	3.03
Location	Land Side
Category	Earthen Levee
Item	Encroachments

unauthorized fence located landward in RD 307.

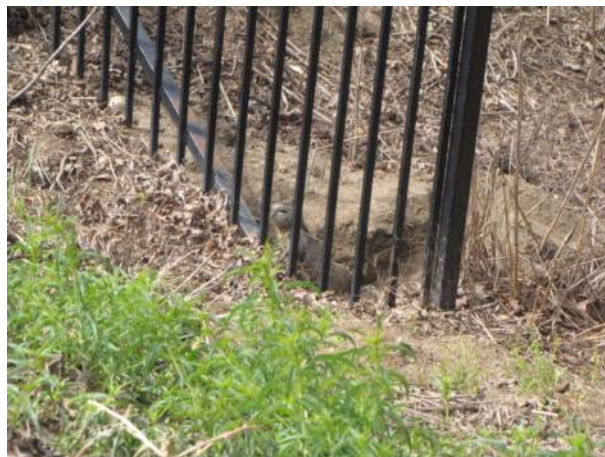
Levee Mile Report Line	46
Start Levee Mile	3.54
End Levee Mile	3.56
Location	Land Side
Category	Earthen Levee
Item	Animal Control

Photo shows live rodent near fence out side of his burrow.

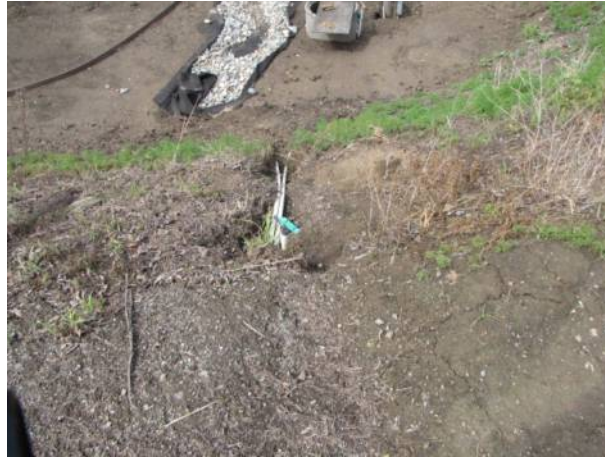
Levee Mile Report Line	47
Start Levee Mile	3.54
End Levee Mile	3.56
Location	Land Side
Category	Earthen Levee
Item	Encroachments

Photo shows pvc pipe placed in levee slope. 4 sprinklers are placed in slope.

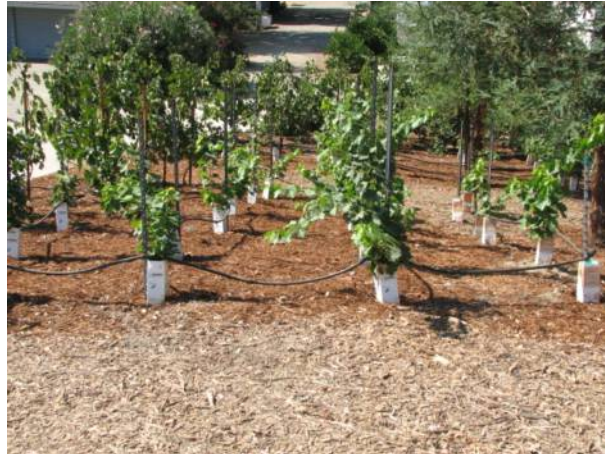
Levee Mile Report Line	61
Start Levee Mile	4.43
End Levee Mile	4.44
Location	Land Side
Category	Earthen Levee
Item	Encroachments

Unauthorized grape vines with driplines placed within levee shoulder and slope, levee miles 4.43 to 4.44 38.443798 121.50332 and 38.44365086 - 121.50322 land side. There is no Permit for this Encroachment.

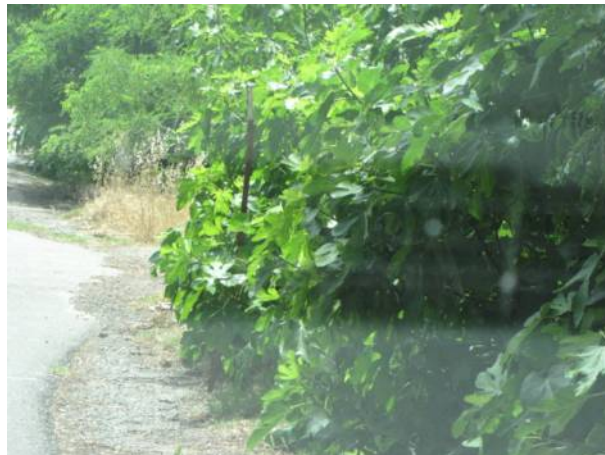
Levee Mile Report Line	67
Start Levee Mile	4.78
End Levee Mile	4.83
Location	Land Side
Category	Earthen Levee
Item	Trim / Thin Trees

Looking down stream from levee mile 4.78 the fig trees has covered the levee section on the land side. The wild growth continues down stream to 4.83.

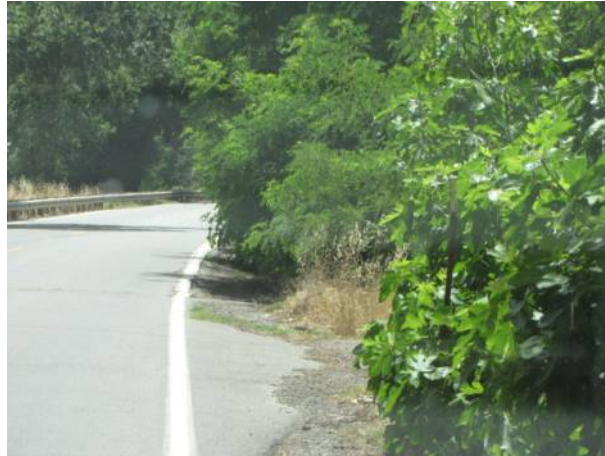
Levee Mile Report Line	67
Start Levee Mile	4.78
End Levee Mile	4.83
Location	Land Side
Category	Earthen Levee
Item	Trim / Thin Trees

Showing the wild growth downstream landward.

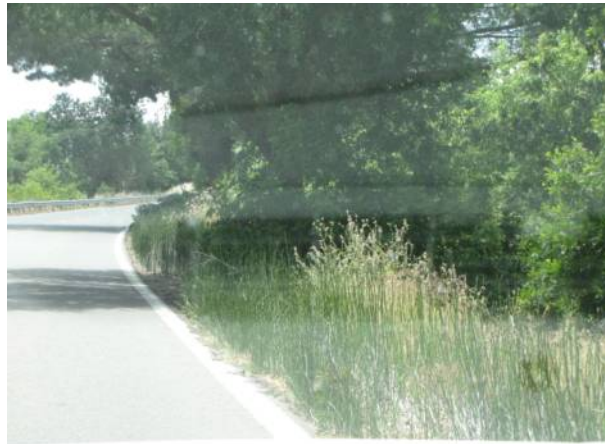
Levee Mile Report Line	72
Start Levee Mile	5.16
End Levee Mile	5.20
Location	Water Side
Category	Earthen Levee
Item	Vegetation

Wild growth on landside at leve mile 5.16 to 5.20 looking down stream.

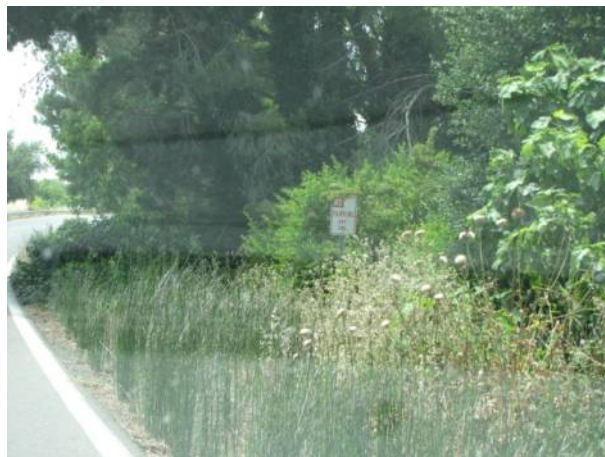
Levee Mile Report Line	72
Start Levee Mile	5.16
End Levee Mile	5.20
Location	Water Side
Category	Earthen Levee
Item	Vegetation

Looking downstream levee mile 5.16-5.20.
